Limited Visual Dam Safety Inspection Summary Report

MA-071

Reservoir 21

May 2006

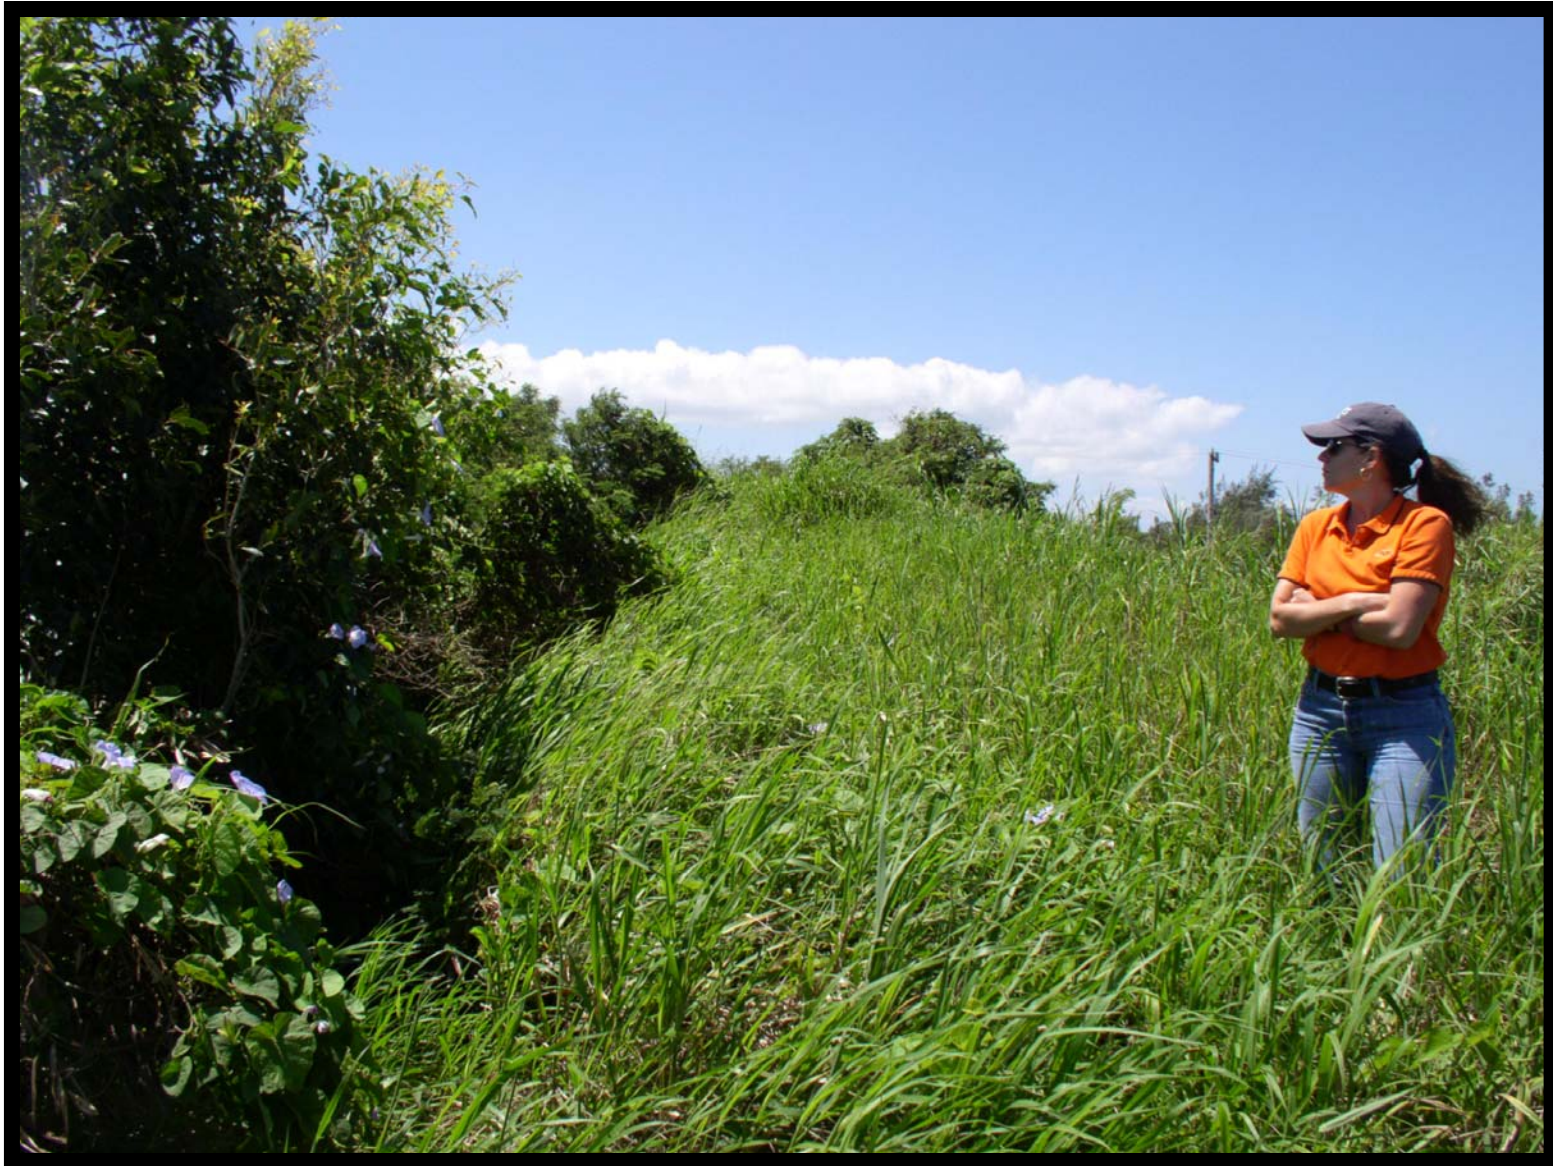
- a. The dam crest appeared to be in fair to poor condition and requires corrective action.
- b. Portions of the crest were not visible due to high grass and bush vegetation. Clear high vegetation and maintain low to enable easy visual inspection.
- c. Trees were observed along the dam crest. Trees have been identified as the probable cause of piping failures and can possibly cause severe damage to the embankment if they are uprooted during high winds. Corrective action is required to remove the tree hazards from the dam. Acceptable remedies include removal of the tree and its root structure down to a 2-inch diameter and reconstructing the damaged embankment section. All repair work shall be accomplished as per the requirements of a licensed geotechnical or structural

071 Crest - Note the tall grass and the trees on the left at the edge of the crest.

engineer. Routinely monitor the damaged area for signs of settlement and seepage.

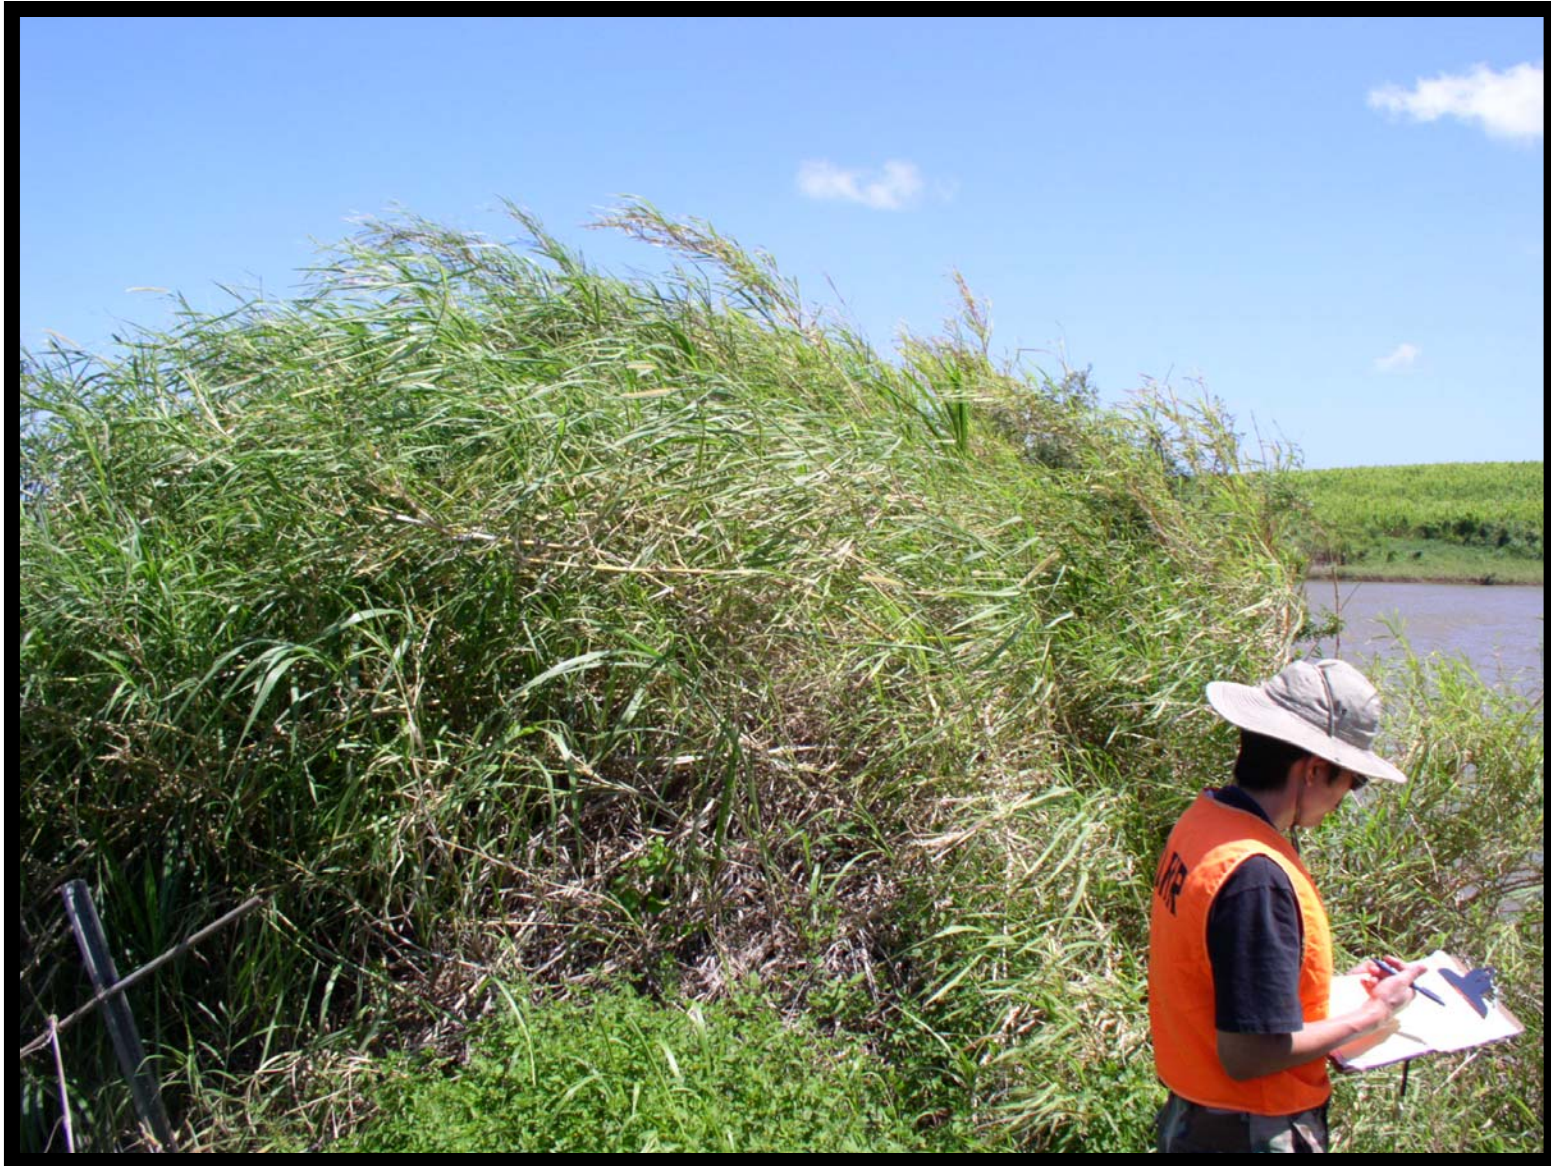
071 Crest 2 - Note the overgrown vegetation which completely obscures the crest.

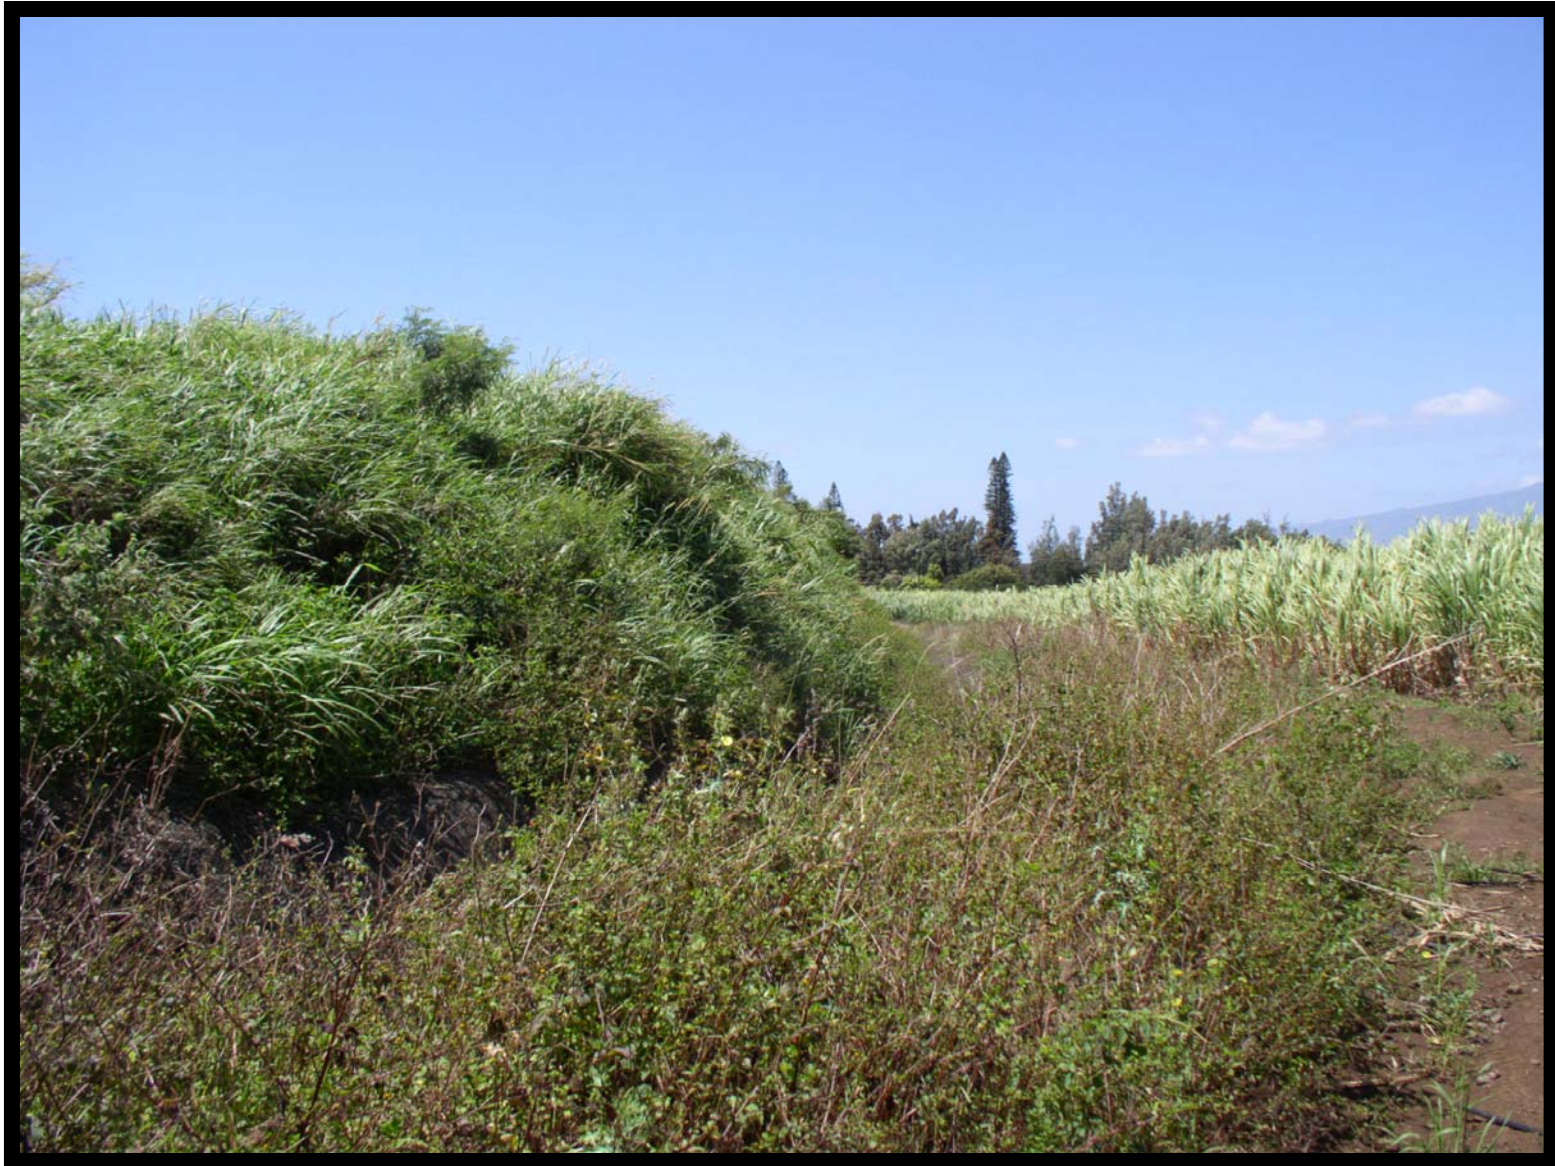
- a. The downstream slope appeared to be in fair to poor condition and requires action.
- b. Slope protection needs maintenance. Need to remove trees and other vegetation from the downstream slope.

- c. The downstream slope was not visible due to high grass and bush vegetation. Clear high vegetation and maintain low to enable easy inspection.
- d. Trees were observed on the downstream slope. Trees have been identified as the probable cause of piping failures and can possibly cause severe damage to the embankment if they are uprooted during high winds. Corrective action is required to remove tree hazards from the dam. Acceptable remedies include removal of the tree and its root structure down to a 2-inch diameter and reconstructing the damaged embankment section. All repair work shall be accomplished as per the requirements of a licensed geotechnical or structural engineer. Routinely monitor the damaged area for signs of settlement and seepage.

071 Downslope - Note the overgrown vegetation which obscures the downstream slope.

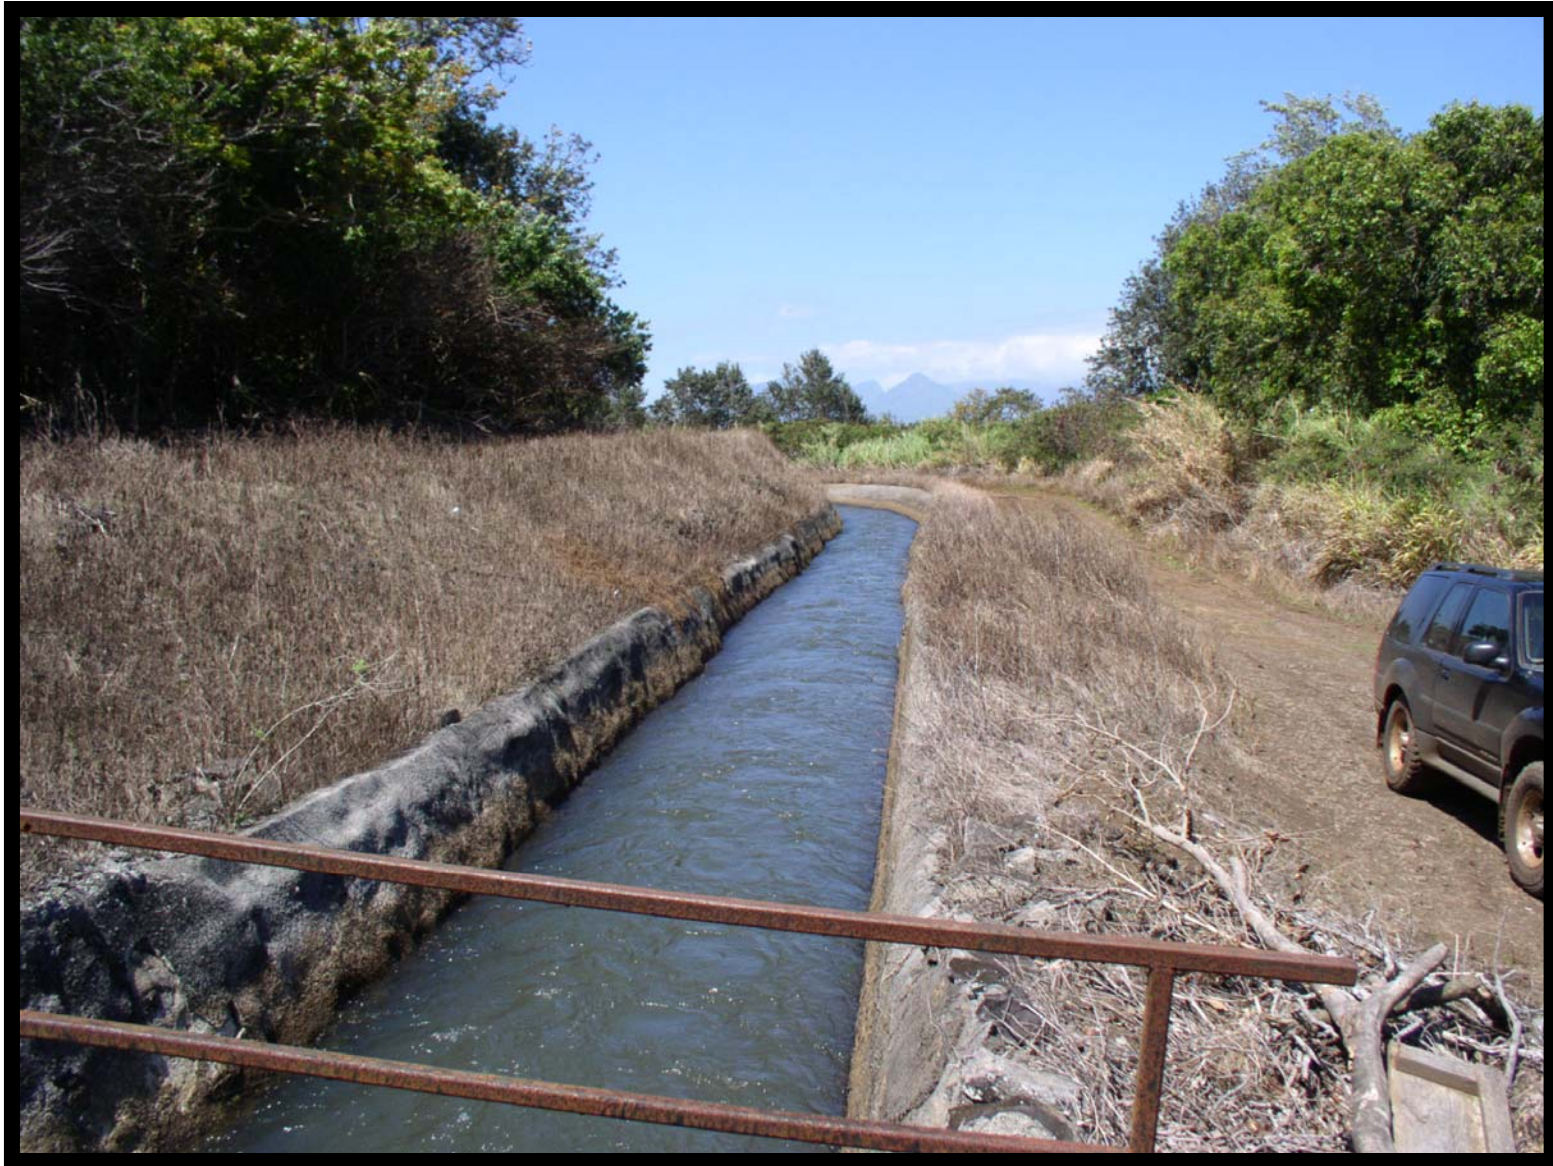
Water flows into the reservoir through an irrigation ditch approximately 10 feet by 5 feet. The intake is controlled by a gate.

071 In channel - View of the irrigation ditch which flows into the reservoir

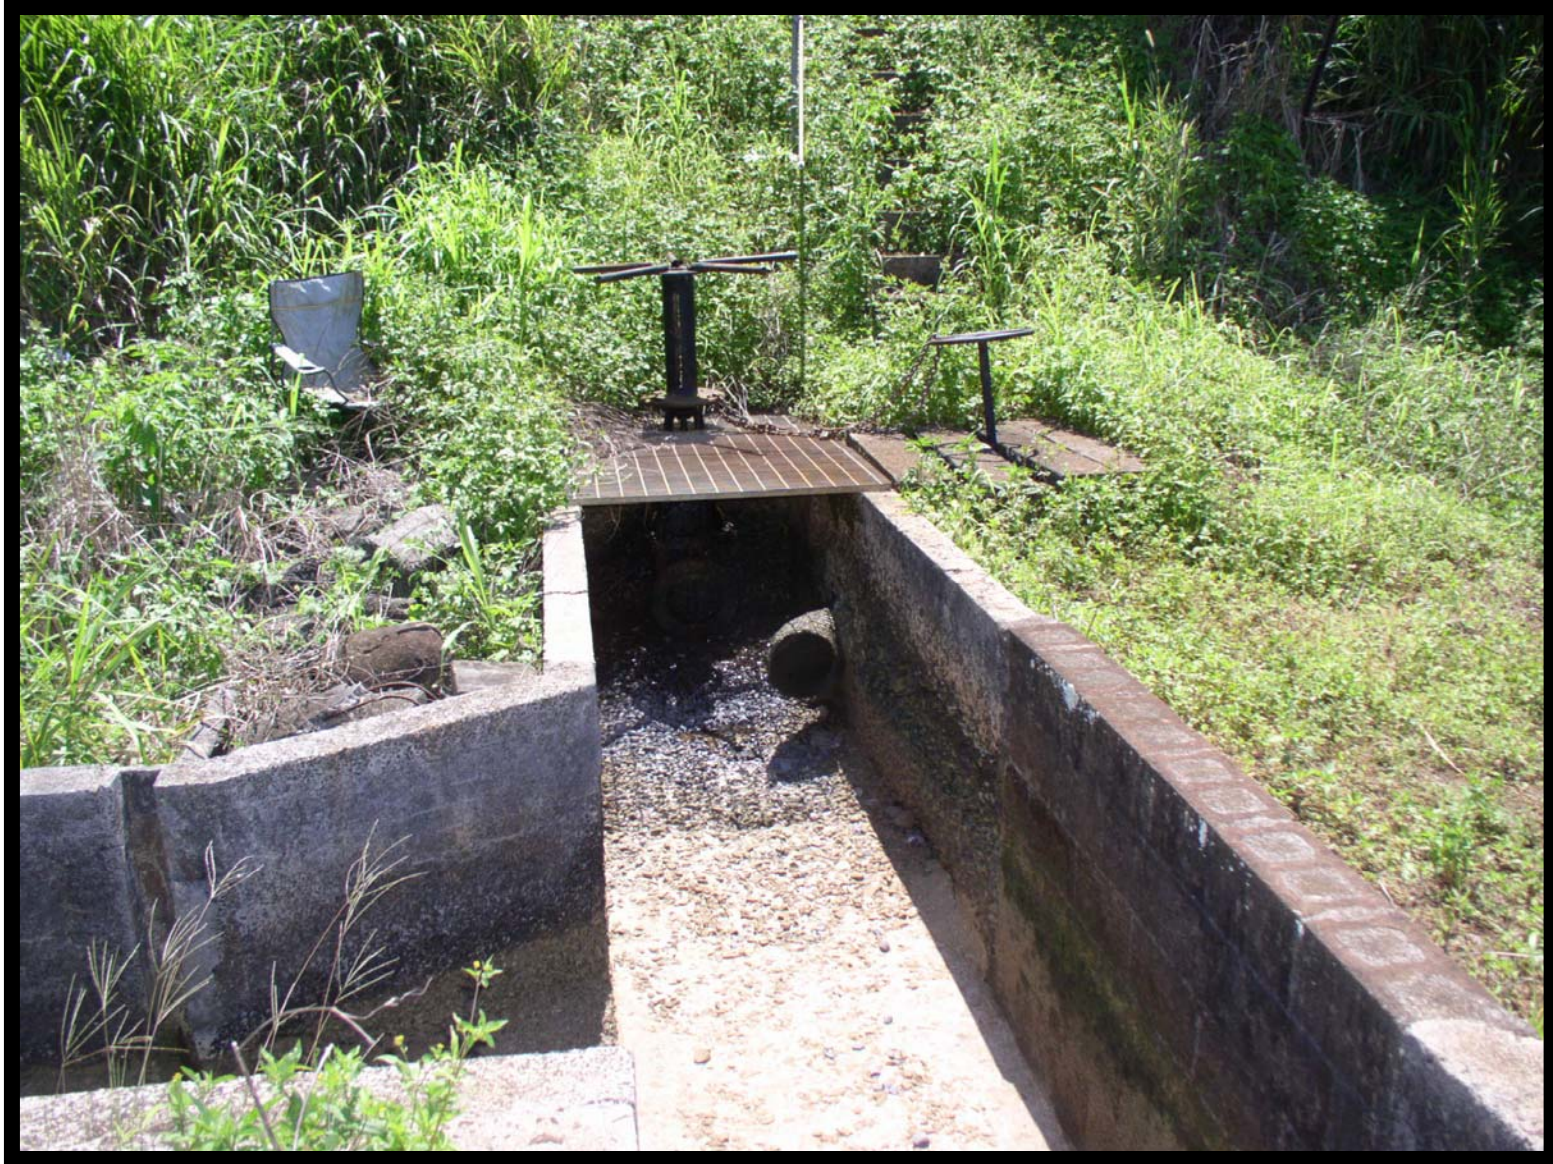
- a. The intake works were not tested.
- b. The intake works appeared to be in satisfactory condition. No corrective actions are required at this time.

071 In valve - View of the inlet and control valve to the reservoir

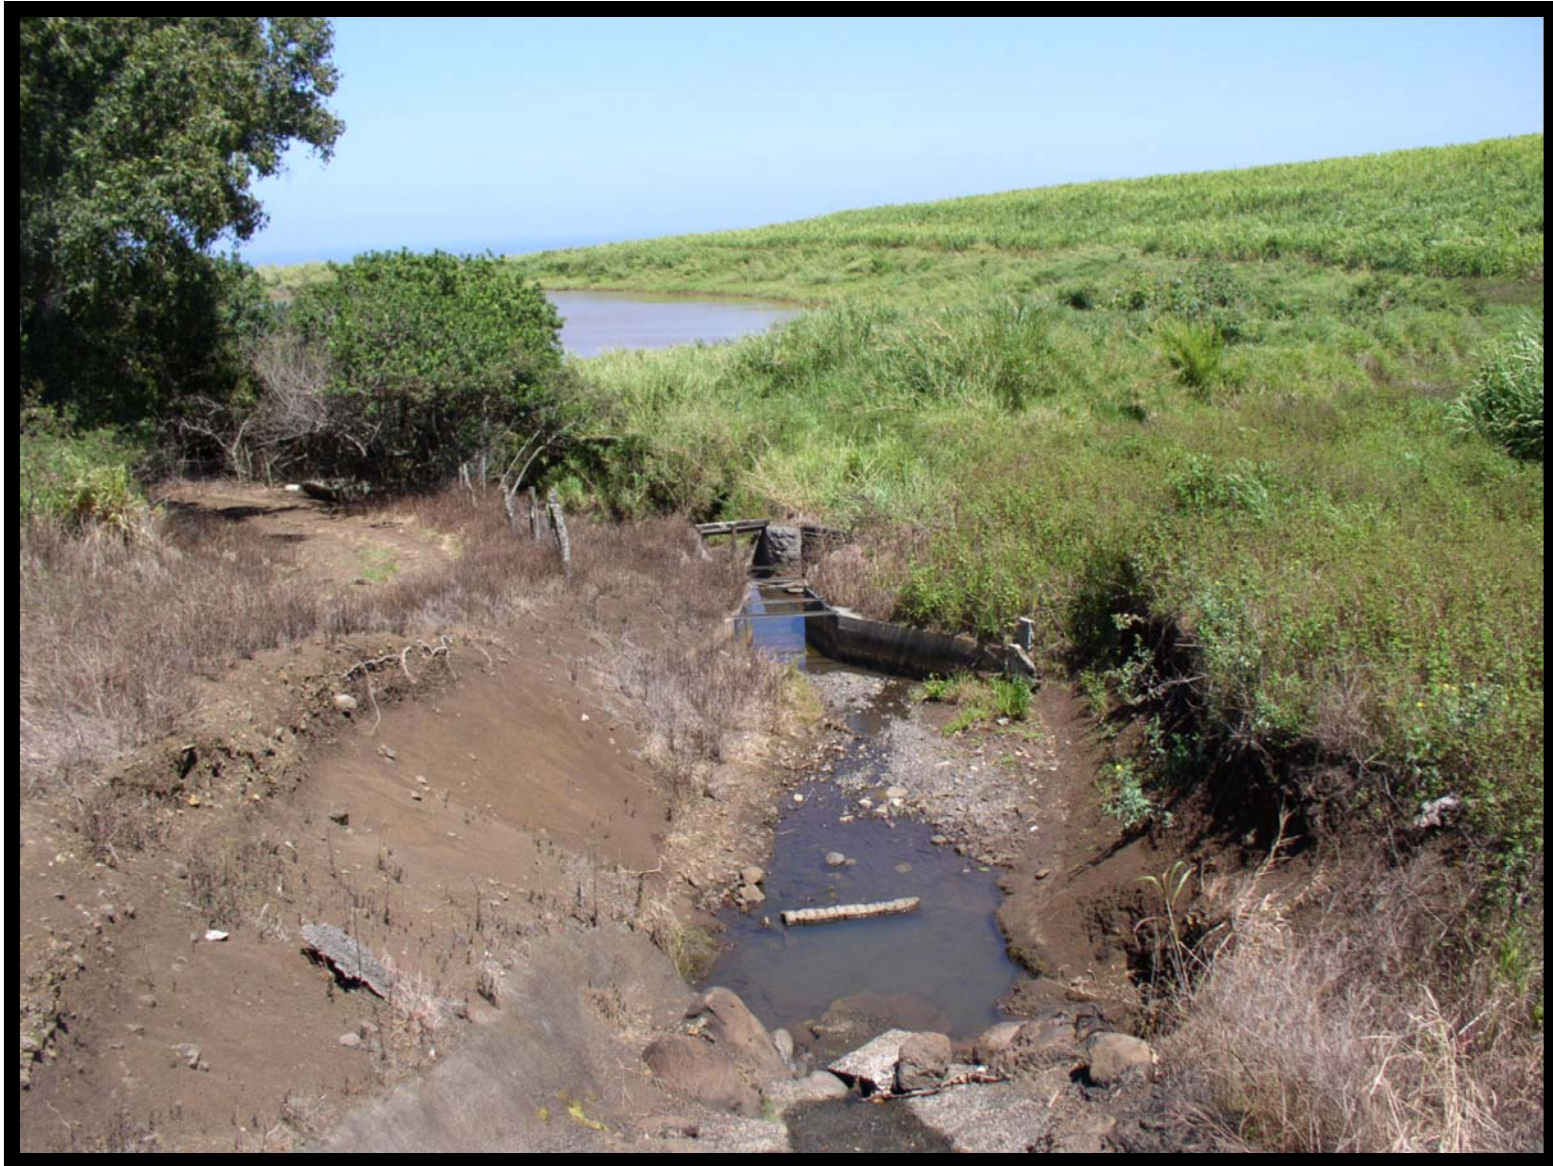
071 Inlet - View of the inlet channel to the reservoir, looking downstream towards the reservoir

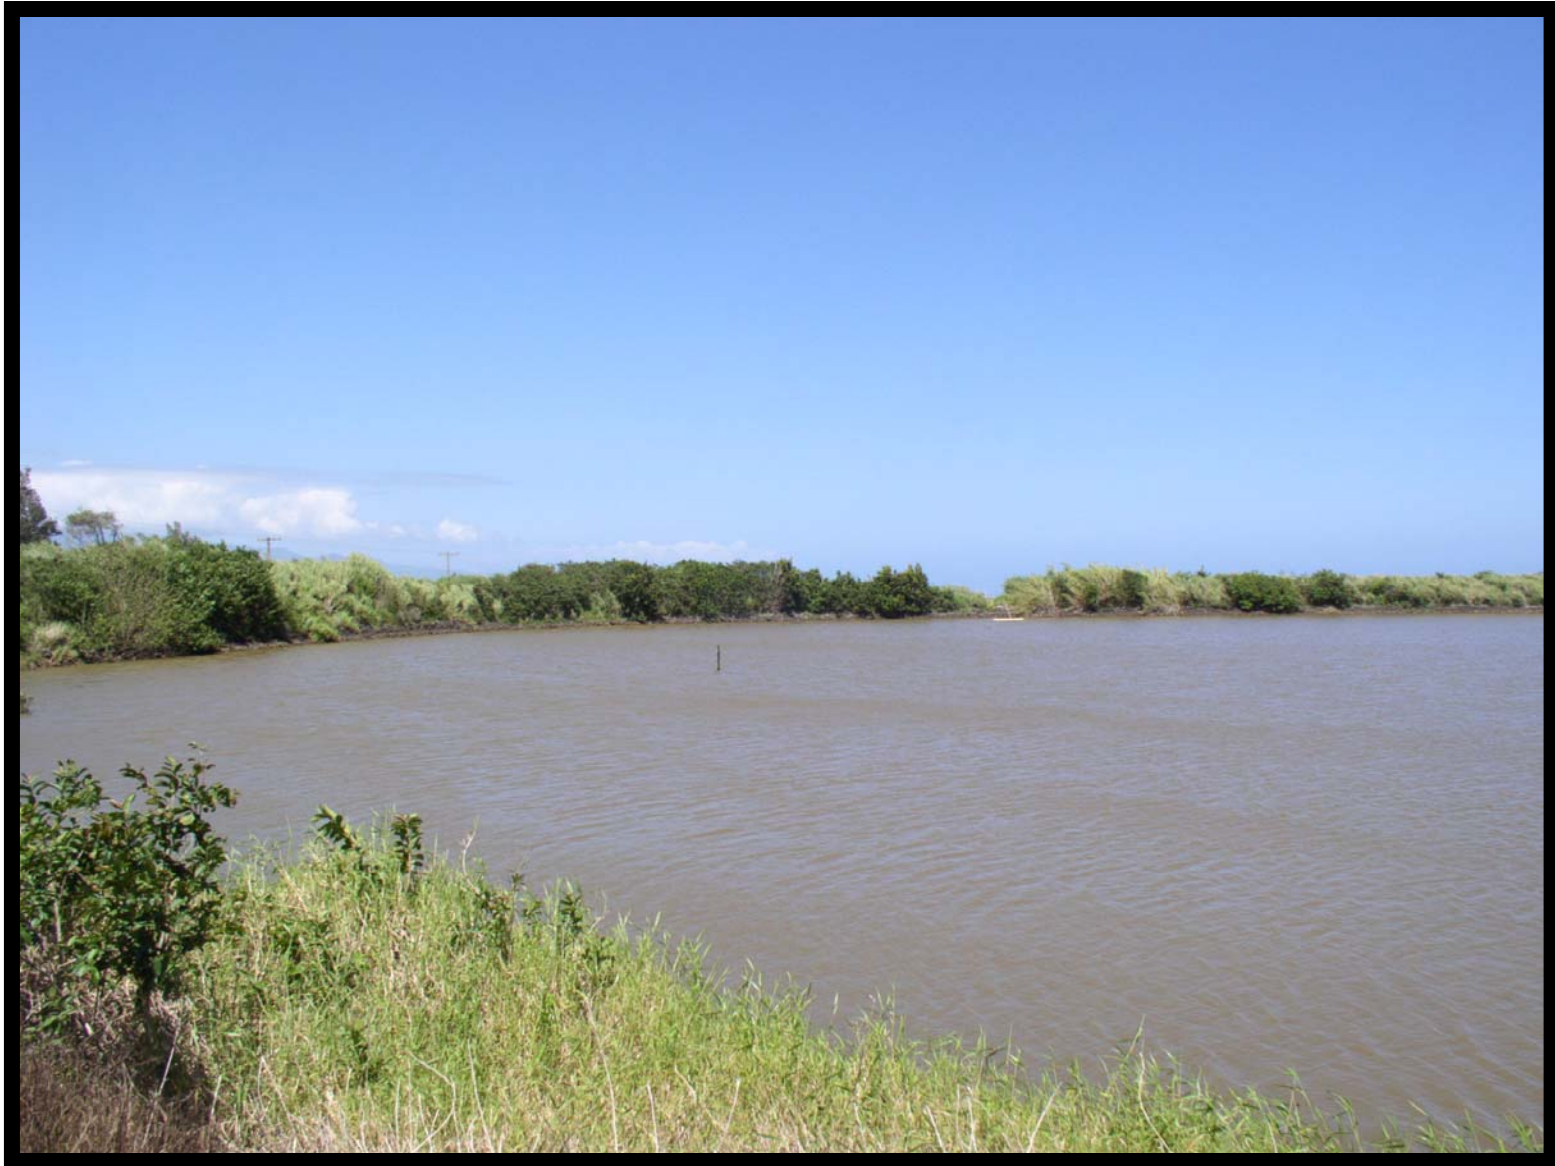
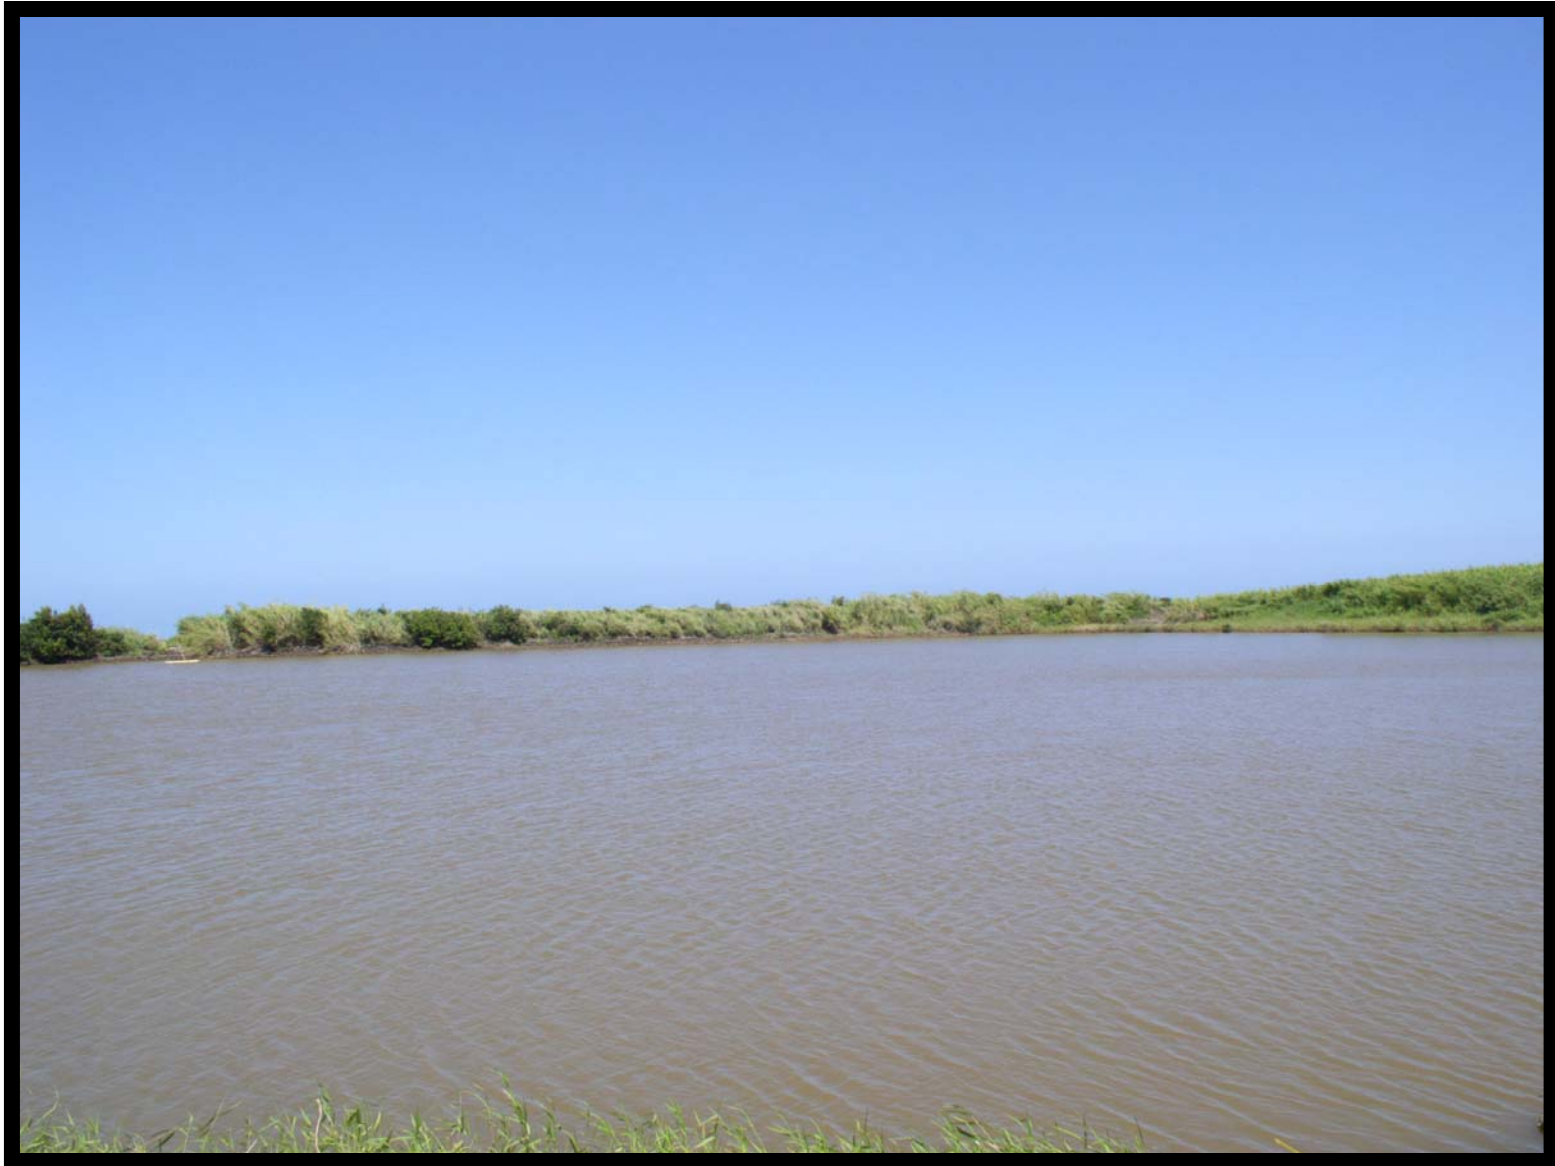
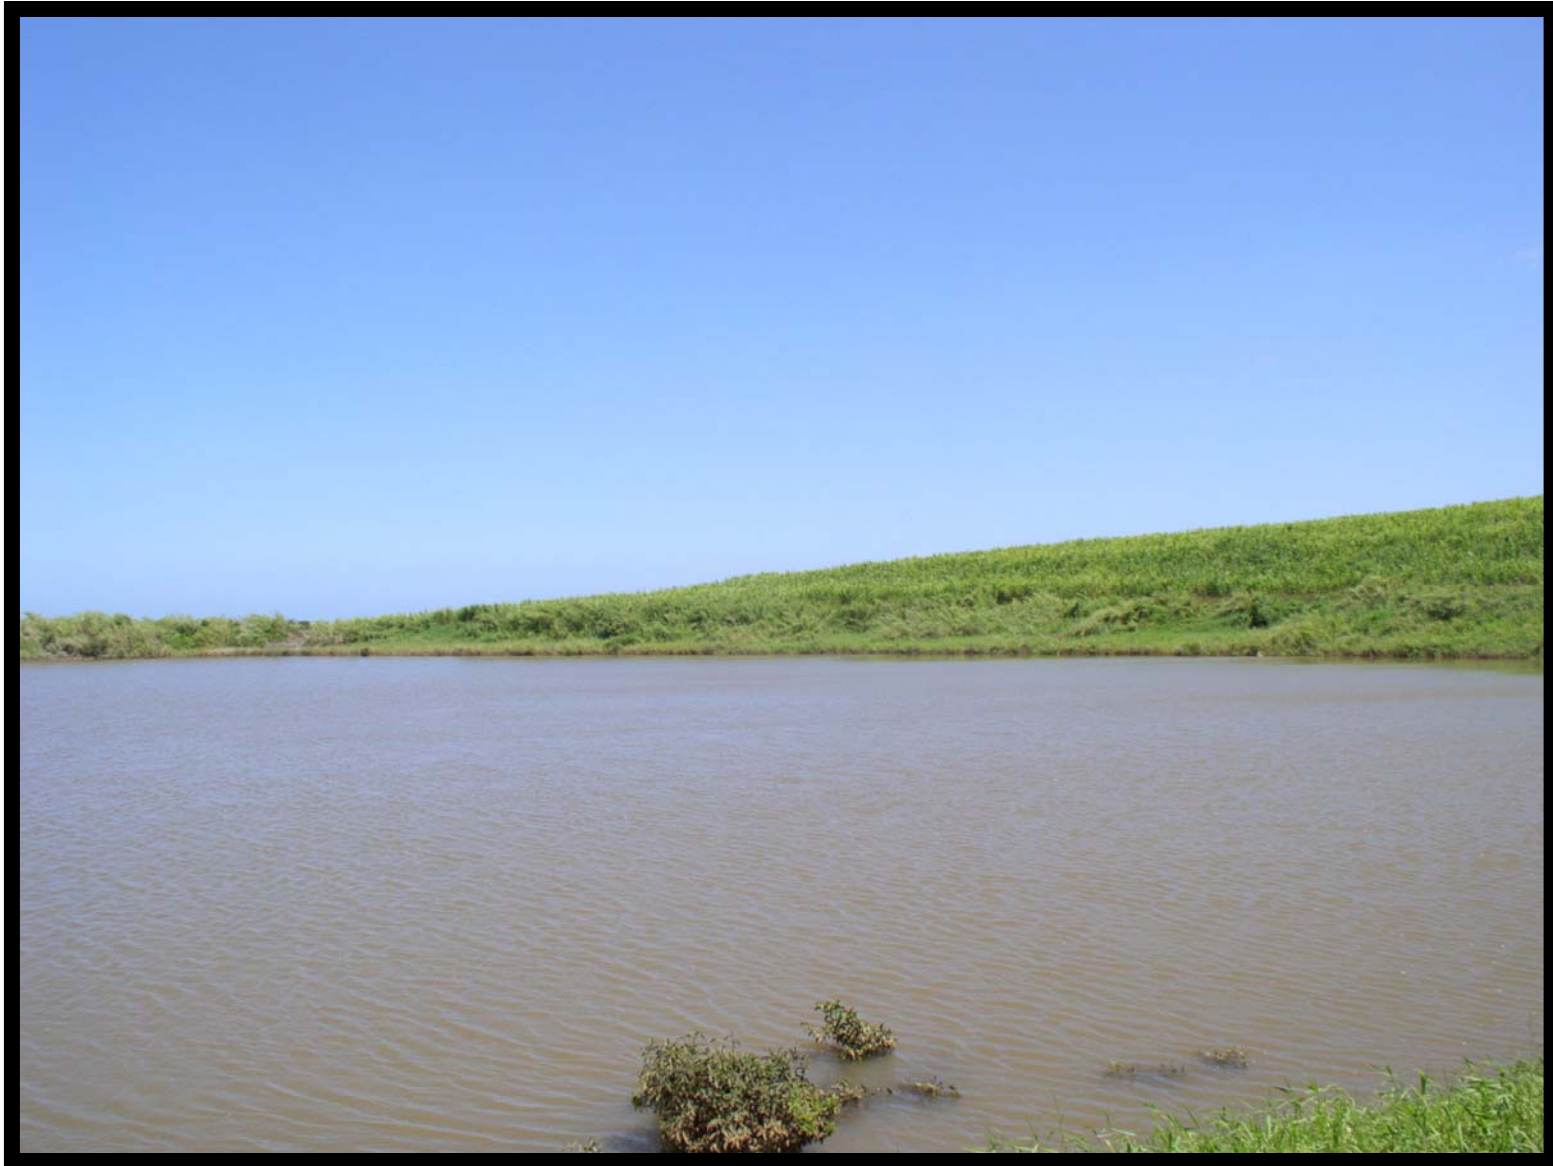
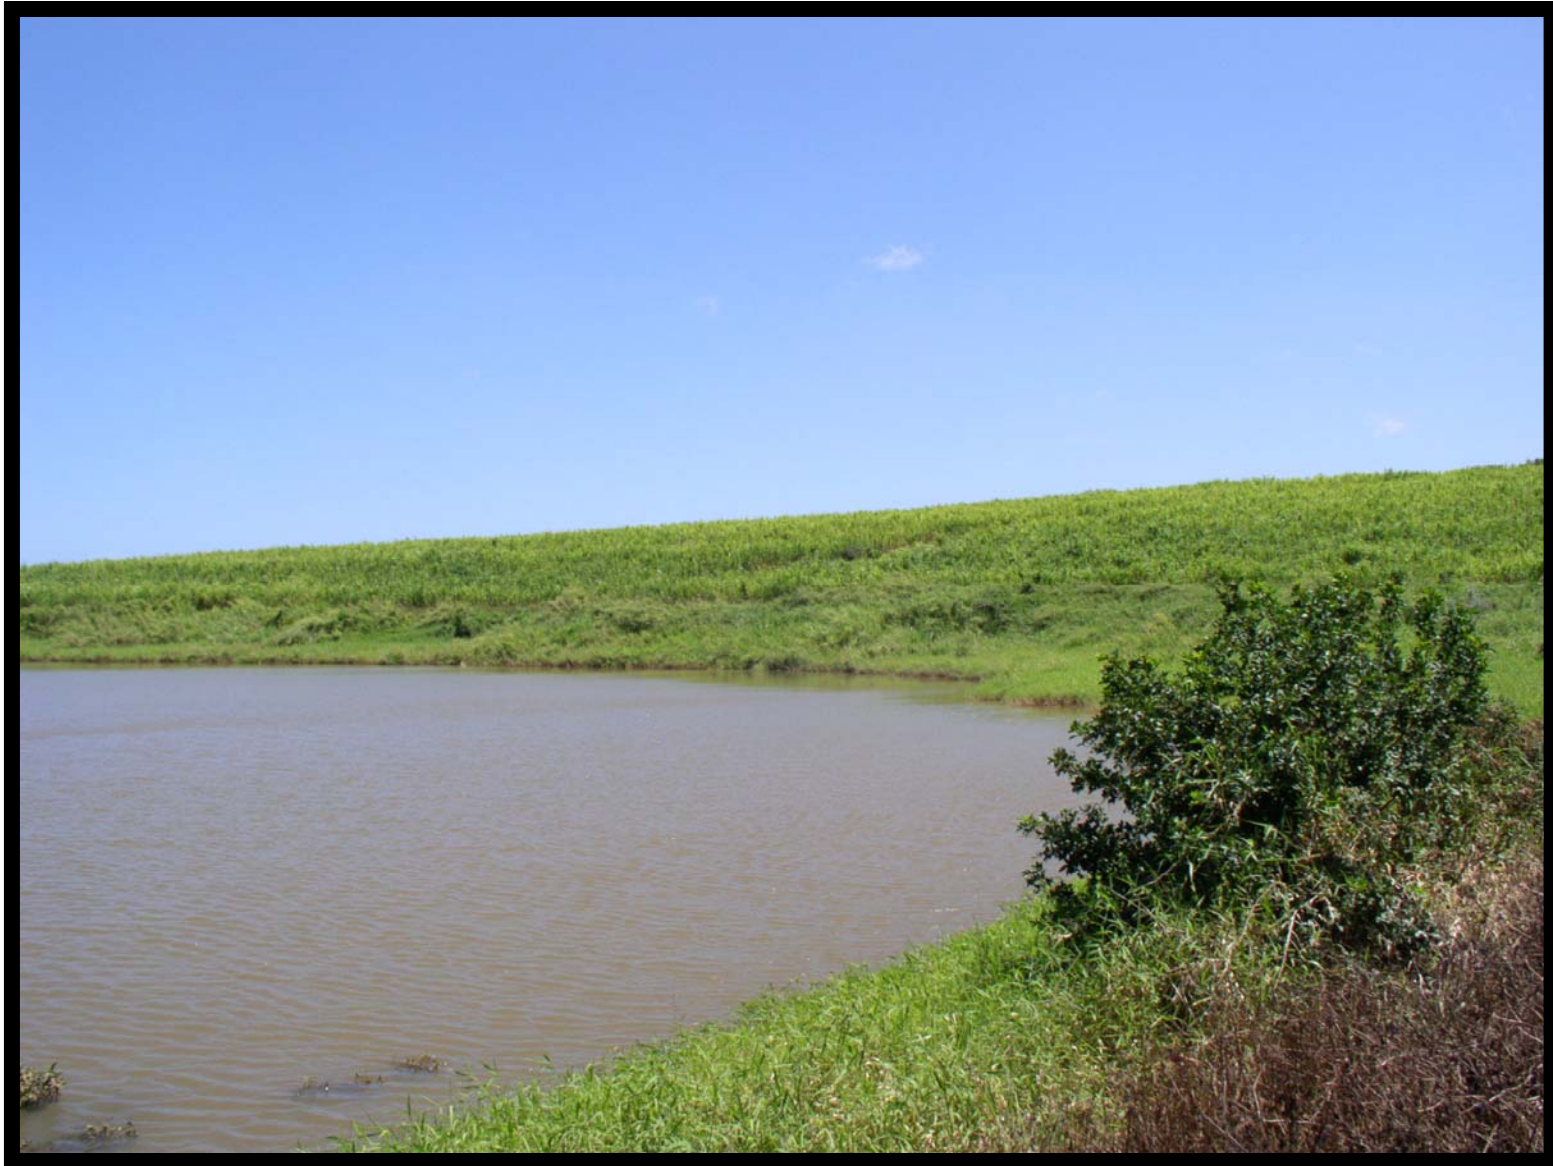
- a. The upstream slope appeared to be in fair to poor condition and requires corrective action.
- b. Slope protection needs maintenance. Description: Need to remove trees and other vegetation from the upstream slope.

- d. Trees were observed on the dam embankment. Trees have been identified as the probable cause of piping failures and can possibly cause severe damage to the embankment if they are uprooted during high winds. Corrective action is required to remove tree hazards from the dam. Acceptable remedies include removal of the tree and its root structure down to a 2-inch diameter and reconstructing the damaged embankment section. All repair work shall be accomplished as per the requirements of licensed geotechnical or structural engineers. Routinely monitor the damaged area for signs of settlement and seepage.

071 Panoramic view of the reservoir, looking downstream at the upper slope

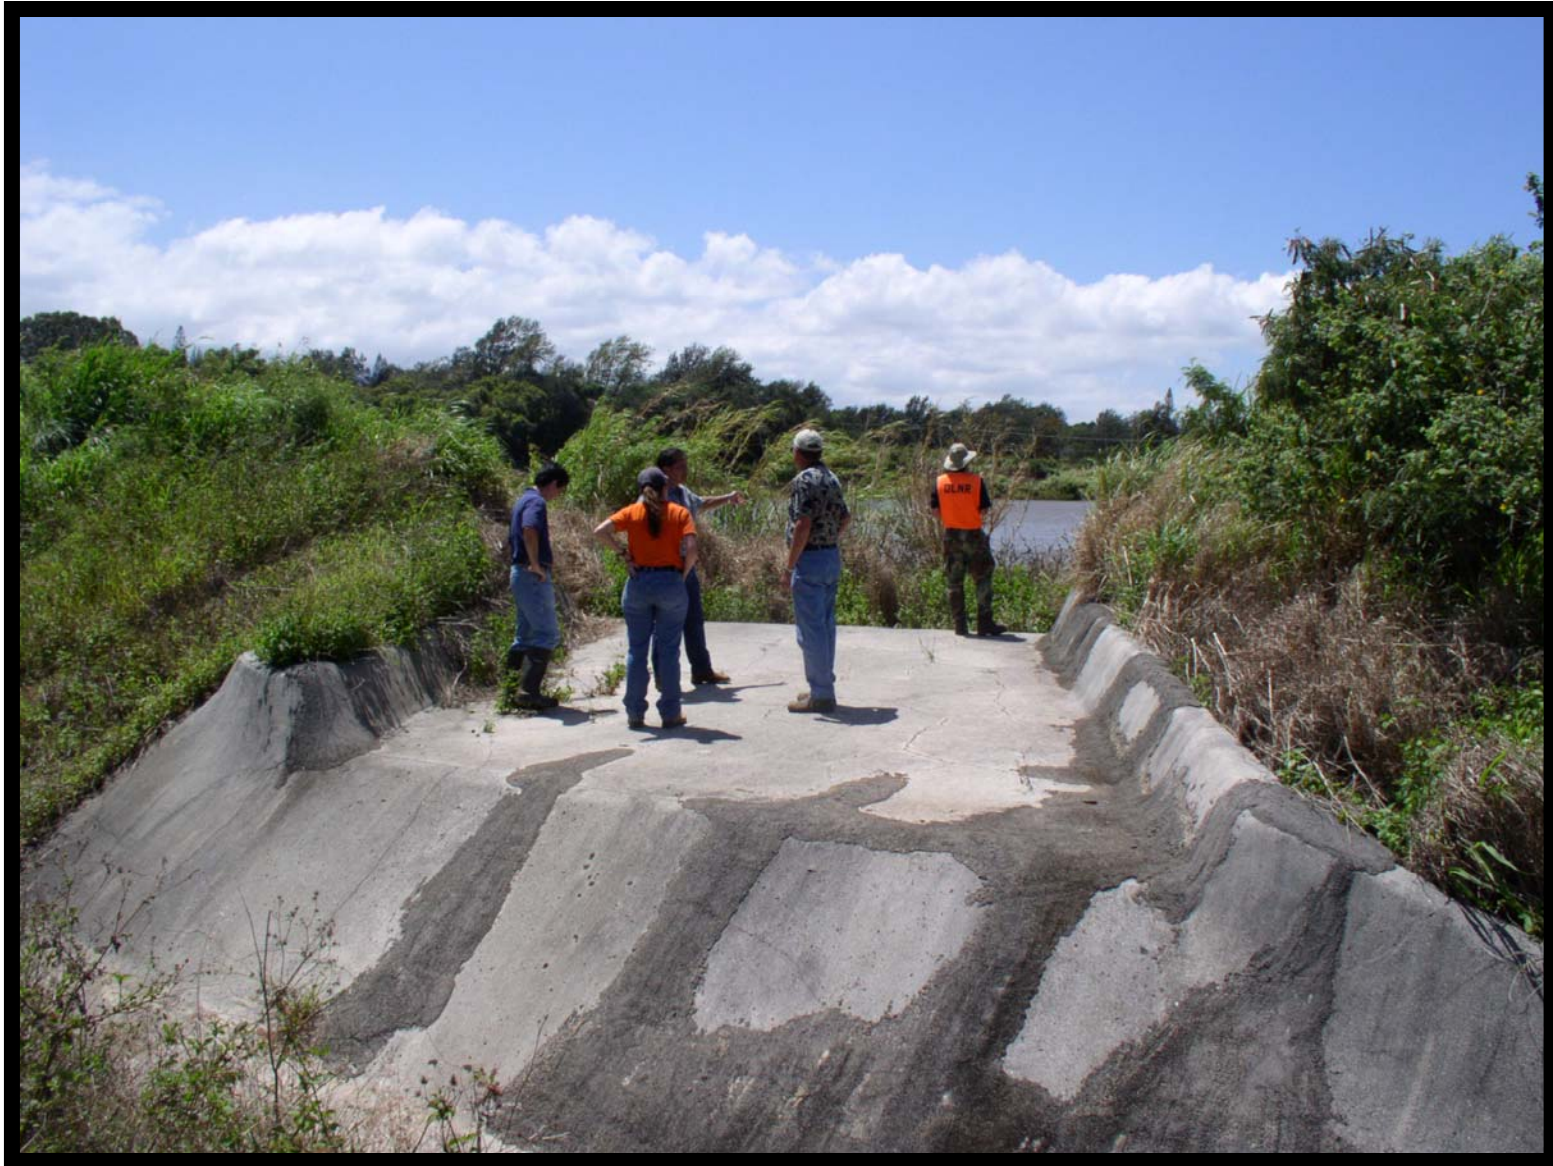
071 Spillway

- a. The Spillway appeared to be in satisfactory condition, no corrective actions are required at this time.
